# Structural Analysis and Strengthening of the National Youth Foundation Building in Igoumenitsa, Greece

Chrysanthos Maraveas, Argiris Plesias, Garyfalia G. Triantafyllou, Konstantinos Petronikolos

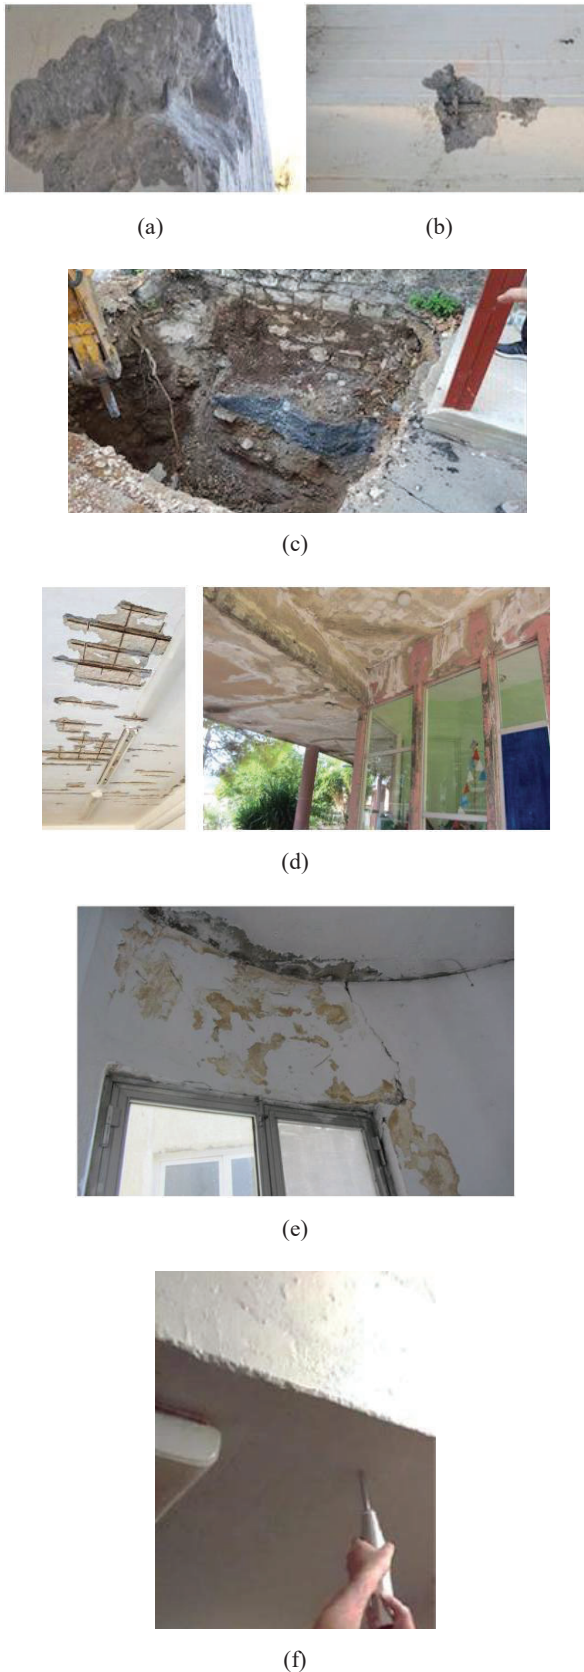
Fig. 3 Disclosure of steel reinforcement materials (a,b), disclosure of the foundation in a column (c), localized damage (d,e), and a non-destructive test (f)

The main objectives of this study were to evaluate the structural adequacy and plan a retrofit of Buildings II and IV, as well as to perform a seismic assessment according to KAN.EPE [1]. In-situ, non-destructive and destructive tests were conducted to further assess the structural condition and details. The cover was removed in order to assess the reinforcement at selected column and beam locations. Locations from the initial construction phase and from the concrete jacketing intervention were accessed in order to verify reinforcement details, as shown in Figs. 3 (a) and (b). A sample excavation was performed to reveal the foundations in a column of Building IV, as presented in Fig. 3 (c). Areas with localized damage were also inspected, as shown in Figs. 3 (d) and (e).

Laboratory tests were also conducted in order to verify the mechanical properties of the materials, as well as the configuration, type, and dimensions of steel reinforcement materials, and the concrete cover depth. A Schmidt hammer [Fig. 3 (f)] and a rebar detection device were also used for this purpose. The compressive strength of the concrete was estimated by testing concrete cores. The carbonation depth of the concrete was also measured. Half-cell potential measurements were conducted in steel bars in order to assess the probability of corrosion in the RC elements.

The experimental results from the non-destructive and destructive tests indicated that the compressive strength of the concrete varied with both the structural element and the time period of its incorporation into the structure. More specifically, the average compressive strengths of cube specimens from the floor slabs of A' and B' in Buildings I, II, and III were 24.60 MPa and 26.22 MPa, respectively. They exhibited standard deviations of 5.99 MPa and 4.50 MPa, respectively. The average compressive strength of concrete in the beams within Building II was 26.86 MPa. The concrete specimens from the folded concrete slab shell from the ground floor of Building IV presented an average compressive strength of 15.33 MPa and standard deviation of 4.31 MPa. The compressive strengths of the concrete jackets placed around columns and beams during the strengthening project were even lower. The average compressive strength of these cube specimens was 15.14 MPa, with a standard deviation of 3.19 MPa. This differentiation in compressive strength between the old and the new concrete was also confirmed via in-situ non-destructive tests with the Schmidt hammer in the relevant positions.

The configuration of the reinforcement materials was captured via local disclosure of steel rebar. Ribbed steel rebar of quality StIII with an average tensile strength  $f_{ym} = 460$  MPa was identified in the main steel reinforcement. Smooth steel rebar of quality St I with an average tensile strength  $f_{ym} = 260$  MPa was identified for the stirrups. Typically, the steel rebar in the supports for the Building IV slab (edge of beam) presented surface corrosion. In addition, significant moisture was noted on the surface of the concrete in the same positions. Corrosion activity was tested by measuring the half-cell potential of the steel reinforcement. The experimental results indicated that the probability of corrosion was over 90% for 54% of the surface of the soffit floor of Building I. The probabilities of corrosion were lower in the soffit slabs of Buildings II and III. Higher concrete carbonation depths were observed in the unprotected parts of the slab near the supports. The long period of abandonment and low-intensity use of the building complex had significant effects on its durability in the face of environmental factors. Despite the successful crack repairs, the ensuing lack of maintenance led to development of moisture, gradual corrosion of some elements, and detachment of the concrete cover. The corrosion half-cell potential measurements indicated further evolution of corrosion, leading to progressive degradation of the load-bearing capacity of the structure.

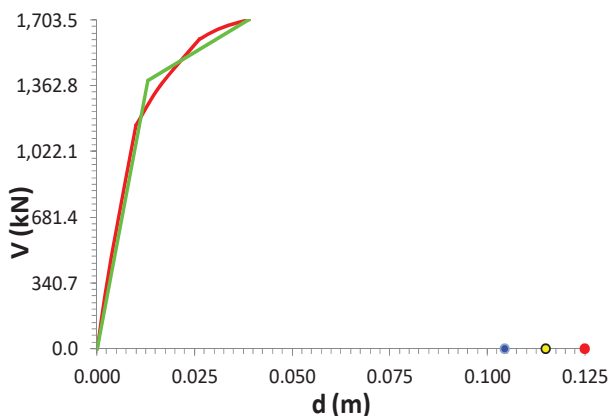
Fig. 6 Force-displacement curve of Building II for a triangular load distribution of the seismic combination  $F_x+0.3F_z$

For Building II, the results from the preliminary elastic static analysis adequacy indicated significant exceedance, expressed as the percentage by which the deficiency factor limits ( $\lambda>2.5$ ). The results indicate that 42% of the main structural elements (columns, concrete walls, and beams) failed. Specifically, 61% of the vertical elements and 33% of the beams failed. Furthermore, tests of the differences between the masses and stiffnesses of various levels in the building, the

average relative displacement between the nodes of the floor, the average relative displacement at x floors, the average relative displacement at z floors and the morphological regularity of the building were not satisfied. However, the criterion that references the upper limits of the building eigenperiods was satisfied. Based on these results, the only feasible method of further evaluation was the inelastic static method (pushover). Pushover analysis confirmed the results of the preliminary test with regard to the inability of the building to withstand seismic deformation at the selected performance level (B1). For at least one load combination, the building was unable to reach the design displacement limit and collapsed as mechanism. This case concerns triangular load distribution of the seismic combination  $F_x+0.3F_z$ . As can be seen in Fig. 6, the building is unable to reach the target displacement.

The main direction of the earthquake changes the requirements for retrofitting and strengthening of the vertical elements significantly. It is obvious that the overall stiffness in the transverse x direction (East-West) is reduced due to the formation of the structure (thin, elongated North-South concrete walls). In summary, Building II required structural strengthening measures in each case, as the structure could not carry the seismic load and meet the minimum requirements for performance level B1.

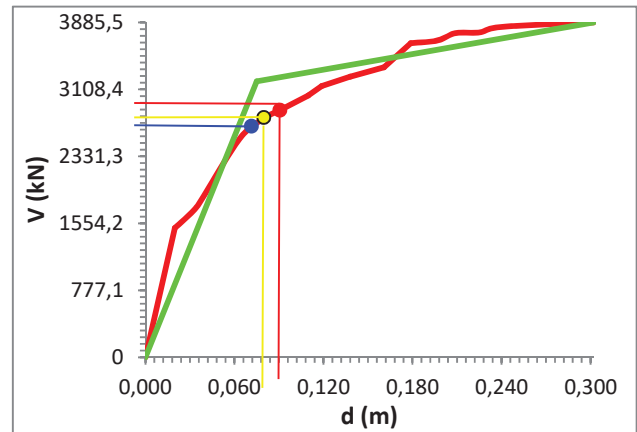
Fig. 7 Force-displacement curve of Building IV for a triangular load distribution of the seismic combination  $F_x+0.3F_z$

For Building IV, the results from the preliminary elastic static analysis check indicated significant exceedance, expressed as the percentage by which the deficiency factor limits ( $\lambda > 2.5$ ) are exceeded. The results indicate that 44% of the main structural elements (columns, concrete walls, and beams) failed. Specifically, 77% of the vertical elements and 23% of the beams failed. Furthermore, tests of the differences between the masses and stiffnesses of the various levels in the building, the average relative displacement at x floors, the average relative displacement at z floors and the morphological regularity of the building were not satisfied. However, the average relative displacement between the nodes of the floor and the criterion that references the upper limits of the building eigenperiods were satisfied. Based on these results, the only feasible method of further evaluation was the inelastic static method (pushover). Pushover analysis

confirmed the significant number of plastic hinge positions and hence the retrofit requirement identified by the preliminary analysis. The results indicate that the direction of the earthquake does not affect the retrofits that are required. In conclusion, Building IV exhibited damage to several structural elements. Retrofitting and strengthening are thus required. The locations where strengthening is required include existing strengthened elements, including beams. This introduces additional difficulties. The force-displacement curve of Building IV for a triangular load distribution of the seismic combination  $F_x+0.3F_z$  is illustrated in Fig. 7.

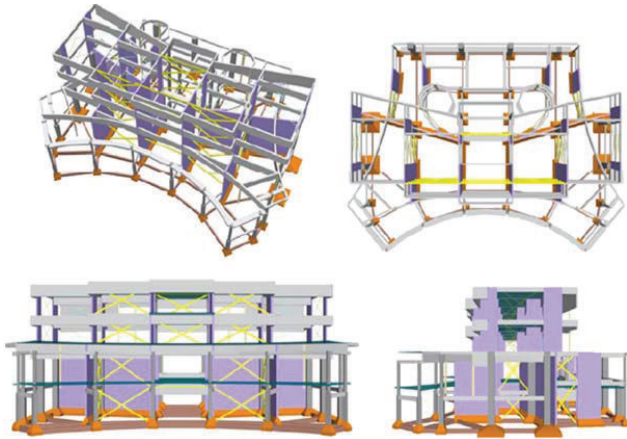
Fig. 8 Building II strengthening proposal with type X steel braces for modeling purposes. The type  $\Lambda$  steel braces allow the access under them

It was not considered appropriate to insert concrete wall elements in the multi-story portion of Building II. This intervention, which removes the flat area on the ground floor, would have changed the character and use of the structure. The retrofitting-strengthening scenarios that were considered as ways of enhancing the bending resistance included the following:

- Type  $\Lambda$  steel braces on three floors and two spans on either side of the center.
- Type  $\Lambda$  steel braces on three floors and three spans including the central one.
- Type  $\Lambda$  steel braces on three floors and two spans on

either side of the center, addition of metal beams that connect to the ceiling in the middle span at all three floors, and addition of smaller type  $\Lambda$  steel braces to the ground floor in the transverse direction to restore wall continuity.

The analytical results indicate that solution c) is the most efficient, as it lets the building achieve the design displacement for each load combination, the global response is improved, and point interventions are reduced. The retrofitting scenario proposed for Building II is shown in Fig. 8.

For Building II, the plan is to strengthen the slabs with shotcrete concrete with embedded steel reinforcement and to strengthen beams and ground floor concrete walls via concrete jacketing. The reinforcement design also calls for construction of an entrance ramp and demolition of the canopy roof and stairs. Furthermore, the corroded concrete surfaces are to be repaired by applying anti-corrosion measures. The structural interventions for the construction of the new frame elements to be inserted between the RC elements include type  $\Lambda$  or K steel braces that consist of horizontal and vertical elements, as well as diagonal configuration links of the desired morphology. The total cost of restoring and strengthening Building II is thus estimated to be approximately 450.000€.
