## **Capacity assessment and strengthening of pre-stressed concrete girders: A case study**

The present case study investigates the capacity assessment and subsequent strengthening of pre-stressed concrete girders and provides additional information on the strengthening measures taken for the whole of the structure involved. It is based on an existing concrete building constructed in 1971. Structural modifications had to be made to ensure a proposed load-bearing capacity upgrade due to change of use.

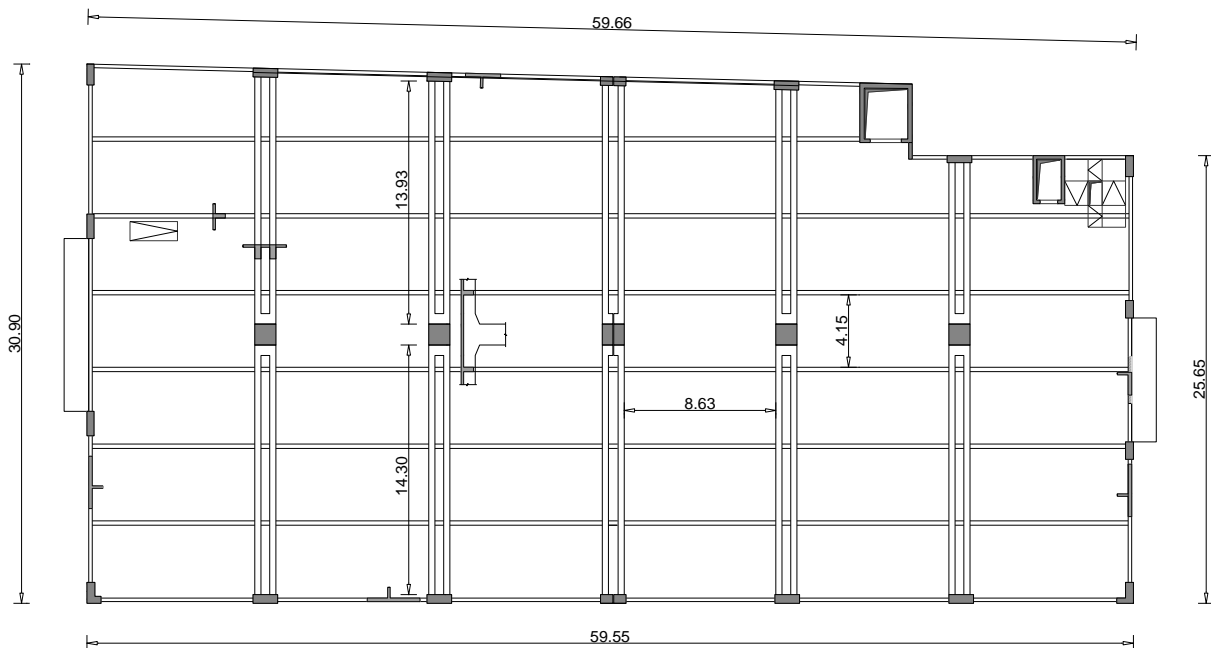
Fig. 1 Plan view of the ground floor formwork

The structural system consists of concrete frames with pre-stressed two-span twin girders (primary beams) in the transverse direction and simply supported pre-stressed girders (secondary beams) in the longitudinal direction. The maximum lengths of the beams are 15.15m and 9.95m for each direction respectively, whereas the cross-section of the examined girders varies from 20/60 cm to 35/80 cm. The geometry of the ground floor formwork is presented in Fig. 1.

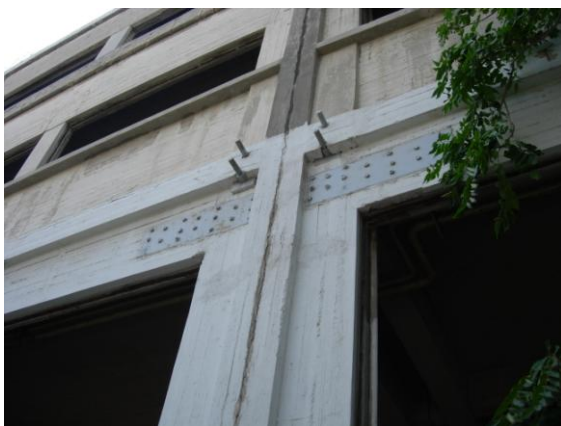
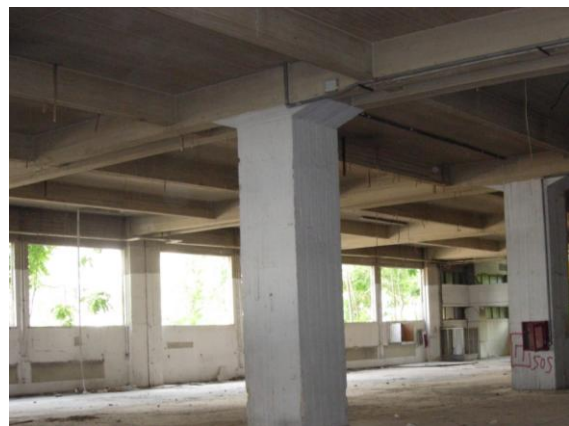
Fig. 2 (a) Exterior and (b) interior views of pre-stressed concrete girders

In Fig. 2, one can observe (a) the anchorage type at the exterior view of the building and (b) an interior view of the first floor, where the structural members are clearly visible. In Fig. 2a, steel plates can also be noticed, which contribute as shear reinforcement on the first floor external joints, most likely due to some kind of failure against seismic actions in the past.

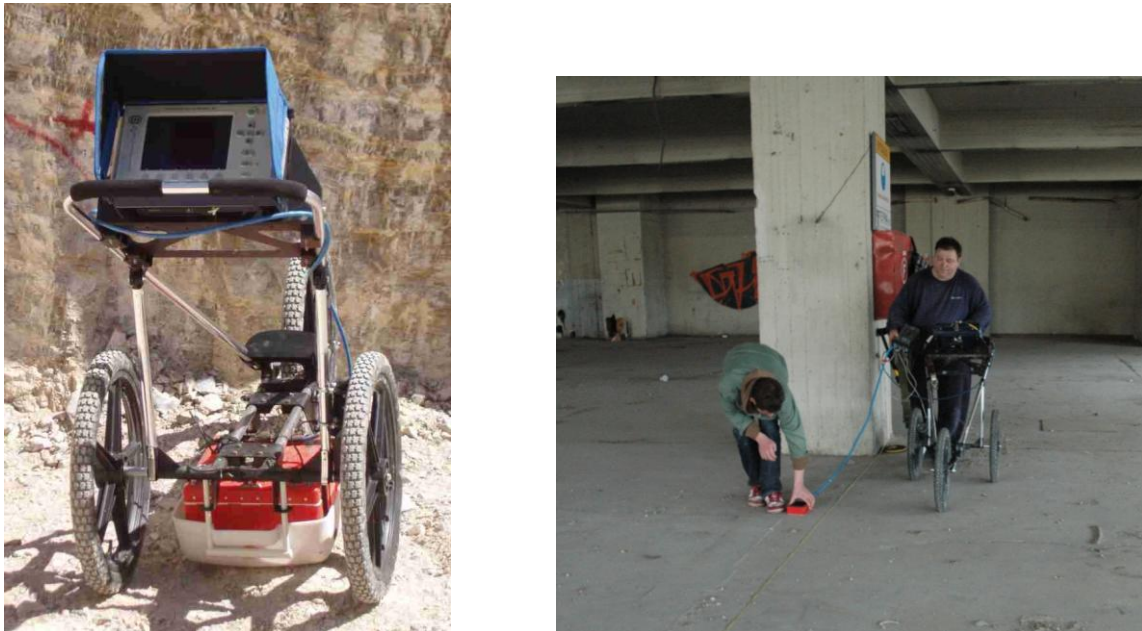
Fig. 3 Detection of tendons using modern geophysical methods

Subsurface radar has become an established investigative tool for assessment of concrete structures, while it has been proved useful for locating steel tendons in pre-stressed concrete; in this study it was applied according to ASTM specifications. Before the device is placed over a beam under examination, its last position is confirmed through an investigation on the transverse direction. The georadar device is presented in Fig. 3.

For further assessment of the tendon geometry, other non destructive methods had to be applied. To this end, a georadar method was utilized, which consists of transmitting low frequency electromagnetic signals which give notification for each identified interface that separates areas that has a different dielectric constant. The reflected energy proportion depends on the variance of the dielectric constant.

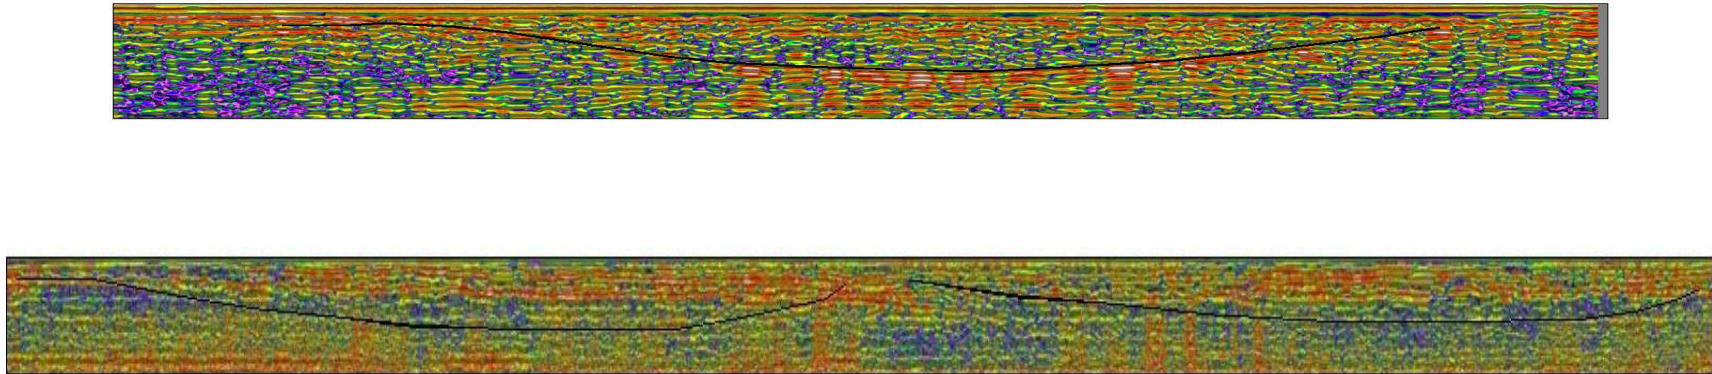
Fig. 4 Georadar method results along pre-stressed girders in graphical form (not to scale)  
(Top: secondary beam / Bottom: Primary beam)

For the detection of the tendons along the entire beam length, a continuous recording was preferred over selective point recording. In Fig. 4, one can identify the tendon pathway along the pre-stressed girder. The aforementioned procedure was repeated for a large number of beams for each floor (approximately 120 tests in total).

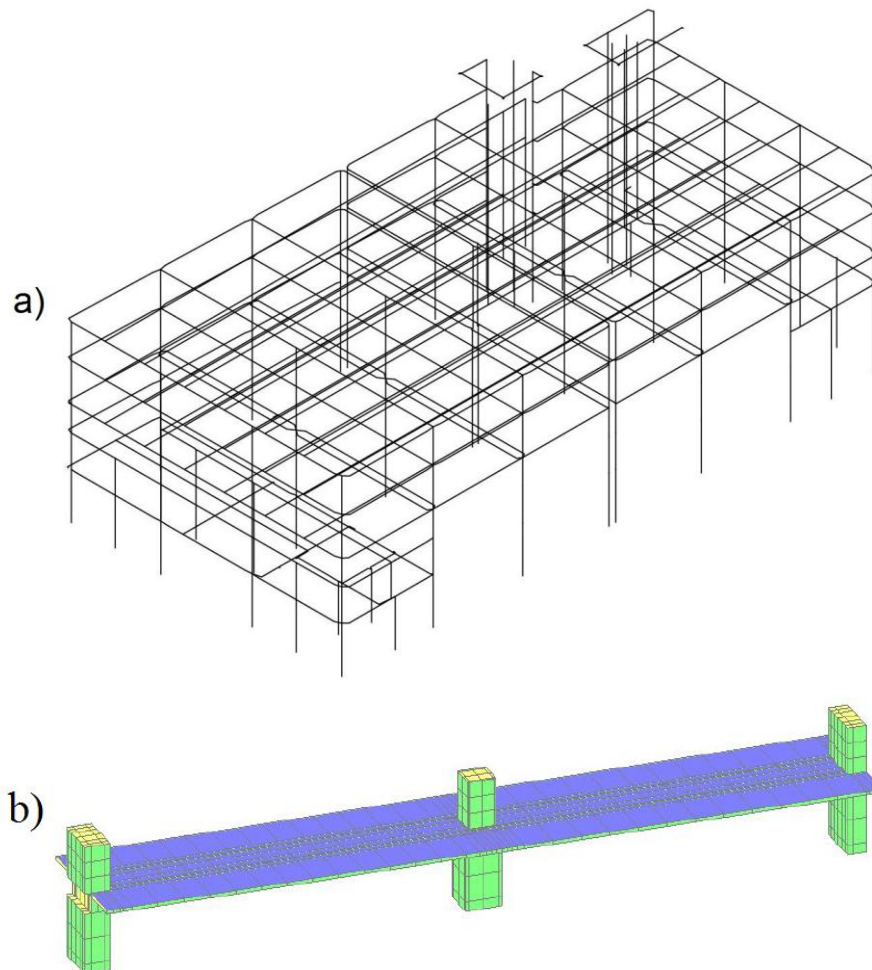
Fig. 5 3D views of the models used to simulate a) the overall structure and b) a two-span pre-stressed girder

The existing structure was simulated as a three-dimensional model, using beam elements for the beams and columns. Apart from the overall structure, the separate simulation of singular pre-stressed beams was also deemed necessary. In this case, the columns were included for up to half the level height above and below the girders, in order to simulate the appropriate boundary conditions for the beam ends. In Fig. 5, 3D views of both models are presented.

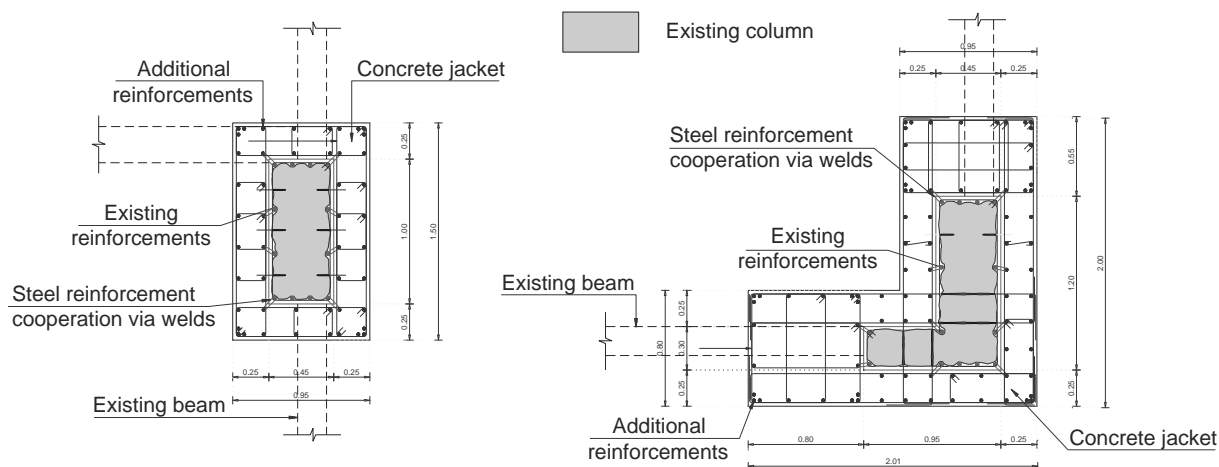
Fig. 6 Cross-sections of modified concrete columns

The modified cross-sections of two perimeter columns of the ground floor are presented in Fig. 6.

All concrete columns along the building perimeter were coated with reinforced concrete jackets of minimum 25cm thickness, in order to improve resistance against seismic loads. For the same purpose, 10cm thick jackets were applied on the internal columns. The primary pre-stressed beams were strengthened by increasing the adjacent slab thickness via reinforced jackets in areas around columns, thus improving their T-beam function. Their flexural strength was also enhanced locally by attaching steel plates around them. The increase in slab thickness also solved the problem of slab inadequacy against shear and punching shear forces.

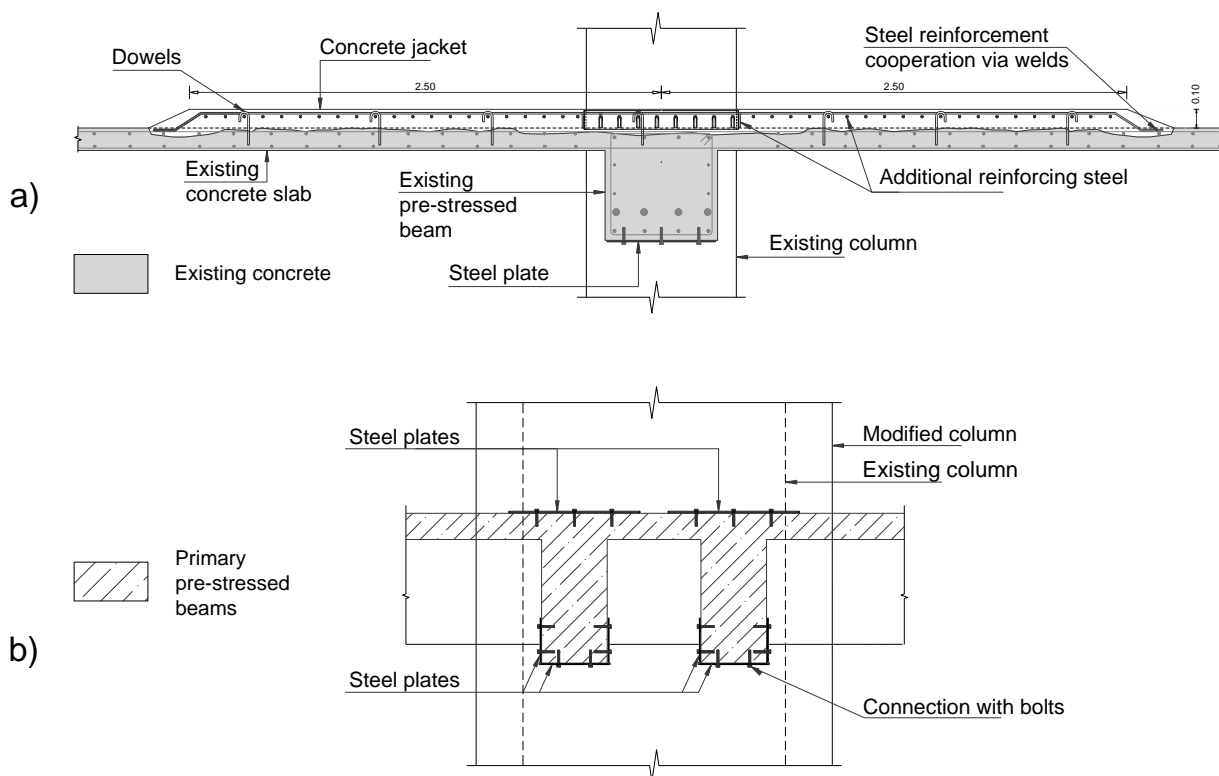
Fig. 7 Cross-sections of pre-stressed concrete beams of a) first floor and b) ground floor after strengthening modifications

In Fig. 7, two examples of primary pre-stressed beam strengthening are illustrated. In particular, one can see the concrete reinforcement of the concrete slab in the area around the column for a first floor beam (Fig. 7a) and the beam strengthening by use of steel plates for a ground floor beam (Fig. 7b).
