STRUCTURAL ANALYSIS AND RETROFITTING OF THE “TZOTZAS” BUILDING IN KASTORIA, GREECE

C. Maraveas, K. Tasiouli, K. Miamis and Z. Fasoulakis

Structural Eng. Dept., C. MARAVEAS PARTNERSHIP
Athens, Greece
e-mail: c.maraveas@maraveas.gr

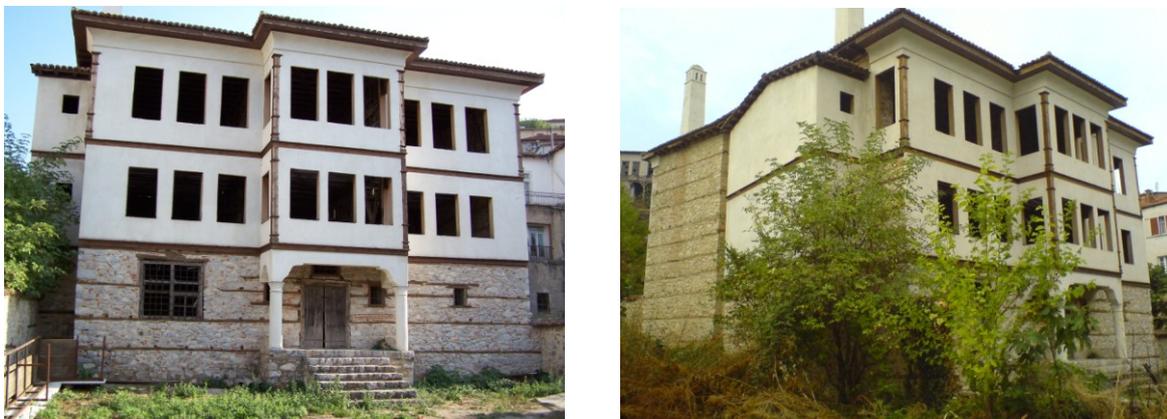
Figure 1: Photographs of the “Tzotzas” building.

The construction of the studied structure dates back to the second half of the 19th century. The “Tzotzas” building (named after its owner) is a traditional mansion house, known as “Archontiko” (in Greek), which contributes to Greek heritage. It has been declared as a “listed” building by the Greek ministry of culture. Therefore, it is mandatory that the retrofit proposal does not to alter its traditional architectural characteristics. Photographic evidence of the exterior of the building (facade) is presented in Figure 1.

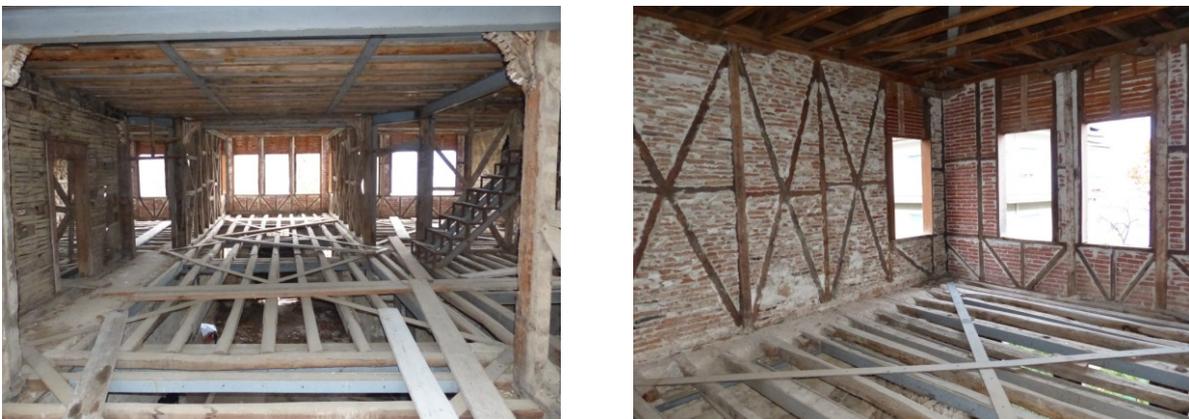
Figure 3: Interior views of the 1st (left) and 2nd (right) floor. The timber framed masonry is clearly visible.

The floors and the roof consist of closely spaced timber beams, some of which have been strengthened in flexure by steel plate attachments. Diagonal bracing from steel laminates has been tied to the timber floors, in order to increase their stiffness and ensure rigid diaphragm behavior. In addition, the stone masonry walls of the ground floor have been locally reinforced with cement-based grouts. Two interior views of the building are presented in Figure 3.
