# Structural Analysis and Strengthening of the National Youth Foundation Building in Igoumenitsa, Greece

Chrysanthos Maraveas, Argiris Plesias, Garyfalia G. Triantafyllou, Konstantinos Petronikolos

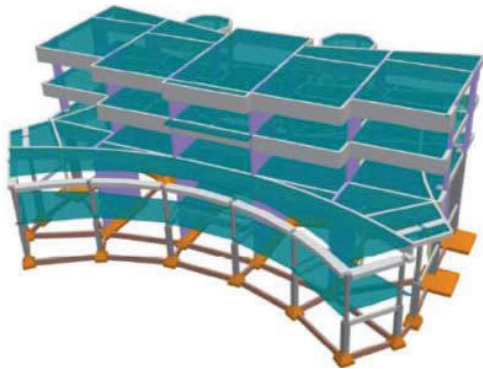
Fig. 4 Illustration of the structural layout of Building II

symmetrical along its North–South axis, as illustrated in Fig. 4. The common methodology of the era was followed, in which concrete slabs were used as surface elements to undertake the vertical actions on each service level of the structure. They carry the vertical loads through a system of beams and then through columns or concrete walls to the ground. The slabs had rectangular cross-sections. Structural meshes of standard dimensions were used as a steel reinforcement. This type of reinforcement is unusual in Greek construction and experiences problems in corrosive environments. Corrosion activity in terms of the residual cross-sections of steel meshes is greater than when other strategies are used, due to the small diameter of the rebar employed (4–6 mm). The slabs were 15 cm-thick, which is considered sufficient for their intended purpose (usual length of 4 m). However, Building II contained slabs that often exceeded 6 m in length. Modern regulations indicate that this thickness is marginal for ensuring the required slenderness. The beams involved had small cross-sections and were reinforced with marginal quantities of steel. This often resulted in under-reinforced elements.

Vertical elements (columns and concrete walls) were placed primarily to satisfy architectural requirements with regard to the arrangement of curved sections on the ground floor for the layout of the stairs. These curved walls were not founded on the ground, but rather were settled on curved beams. In addition, there were small columns on the external perimeter of the building (North–South) that act as point supports and mainly affect the static combinations of actions.

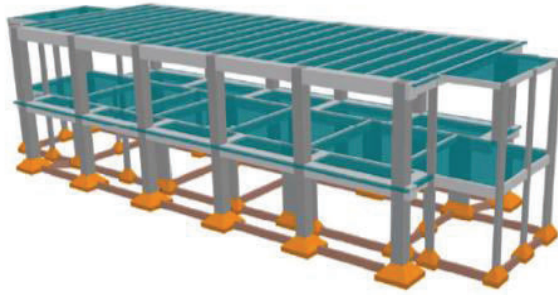
Fig. 5 Illustration of the structural layout of Building IV

Building IV was first designed as a symmetrical RC structure with two symmetrically protruding parts at its eastern and western boundaries, as illustrated in Fig. 5. It is a two-story building with a balcony that acts as a "loft" and that is to be demolished. The layout varies from level to level. Concrete slabs were used as surface elements for transferring vertical actions on each service level of the structure. They carry vertical loads through a system of beams, followed by columns or concrete walls that go to the ground. The slabs have rectangular cross-sections. The slab of the event venue (with a length of approximately 13 m) was a folded concrete slab shell. It was assumed that the vertical elements of the folded concrete slab shell were the beams of the system and the horizontal parts were the small slabs. The behavior of the simulation after the earthquake proved the ineffectiveness of the latter. Structural meshes of the standard dimensions used in Building II had been used as steel reinforcement, producing the problem of cross-section loss in corrosive environments that is mentioned above. The slabs were 15 cm-thick, which is considered sufficient for usual length of 4 m, but for Building IV where slabs often exceeded 6 m in length, this thickness is marginal for ensuring the required slenderness. Beams were reinforced with marginal quantities of steel, which often resulted in under-reinforced elements.

The vertical element structural system consisted of two strong support lines at the floor level that carried the folded concrete slab shell. These support lines consisted of circular columns that behaved unacceptably during the earthquake, failing at their bottoms. These columns were strengthened with concrete jacketing to form an overall cross-section of 75 cm x 75 cm per column. On the ground floor, two additional support lines were constructed with a mixed system of vertical elements (columns and walls) and added to the existing strong columns. Thus, the structural system used to simulate the force imparted by the earthquake was composed of:

The retrofitting techniques of the initial study focused on the installation of strong North–South beams on the ground floor that strengthened the diaphragmatic function of this level even though the connection points with the existing beams did not ensure good function for the nodes. Tensile tendons were installed on the tops of the perimeter columns of the folded concrete slab shell of the ground floor ceiling. Columns were strengthened via concrete jacketing.
