Post-fire assessment and reinstatement of steel structures

Abstract

Paper type Research paper

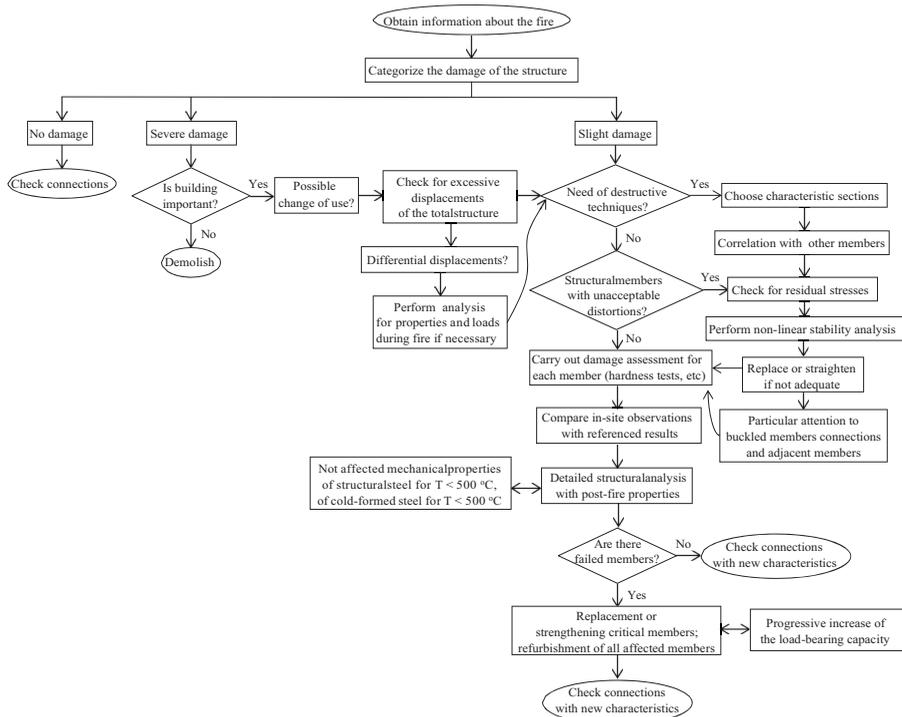
Figure 1. Reinstatement survey flow chart for fire damaged steel structures

The step-by-step process of the fire damage appraisal is dissimilar to the fire resistant design of structures, which can be followed by prescriptive approaches. Figure 1 depicts the reinstatement survey flow chart of steel structures, which illustrates the basic steps.

The first crucial point of the study is to collect information about the fire severity. An initial in-site inspection is required to examine the physical evidence, which is described in detail below (Section 2.2). Specific measurements are carried out, including destructive and non-destructive techniques (Section 2.3). Subsequently, the post-fire mechanical properties are evaluated in accordance with results found in the literature (for which a more elaborated study is presented in Section 3), while the overall capacity of the structure can be examined by conducting structural analyses (Section 2.4). For instance, the excessive resulting displacements can be explained via the proper fire loading simulation. The procedure is completed with the suggestion of the strengthening or the replacement of critical members; some insight information is given in Section 4 of the present work.

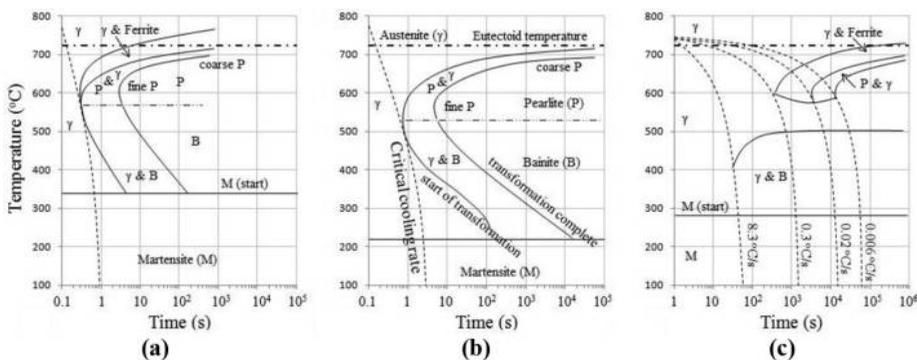
Figure 2. Schematic diagrams illustrating isothermal curves, critical cooling curves and resulting microstructures for (a) hypoeutectoid, (b) eutectoid and (c) alloy steel

Figure 2 demonstrates the isothermal time-temperature-transformation diagrams for three different types of steel: hypoeutectoid steel (less than 0.8 per cent of carbon), eutectoid steel (0.8 per cent of carbon) and alloy steel. First, the steel is held at elevated temperatures, greater than the eutectoid temperature ($A_1 = 727^\circ\text{C}$), where the transformation to austenite begins. The temperature A_3 is associated with the completion of the transformation of ferrite to austenite. It must be noted that for hypoeutectoid steel, A_3 varies linearly, inversely related to the carbon composition ($A_{3,\text{max}} = 910^\circ\text{C}$).

The course of transformation can be completed in either an isothermal or a continuously cooling way. If the austenite is cooled unchanged to a relatively low temperature (M_s), partial transformation takes place instantaneously, producing martensite. This formation attributes to the maximum hardness that can be obtained while the transformation can take place by cooling in water or in ice. The critical cooling rate for each steel type is illustrated in Figure 2.

In contrast, if austenite decomposes at higher temperatures than M_s , the final product can be bainite, pearlite or ferrite with high, medium and low hardness, respectively. This can also be formulated via slower cooling methods, such as cooling in the air or cooling in the furnace. In most plain carbon steels, bainite will not form on continuous cooling because austenite has already transformed into ferrite and pearlite. Cooling in the furnace is usually applied to produce softening (e.g. annealing).

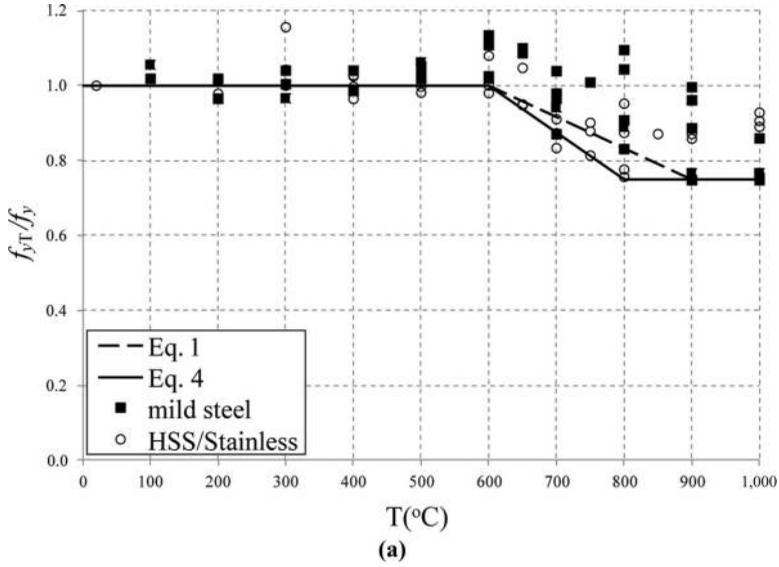
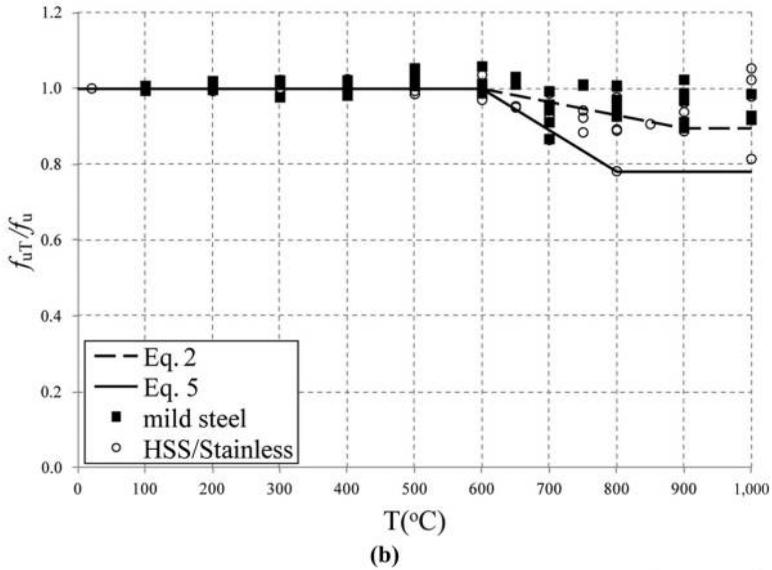
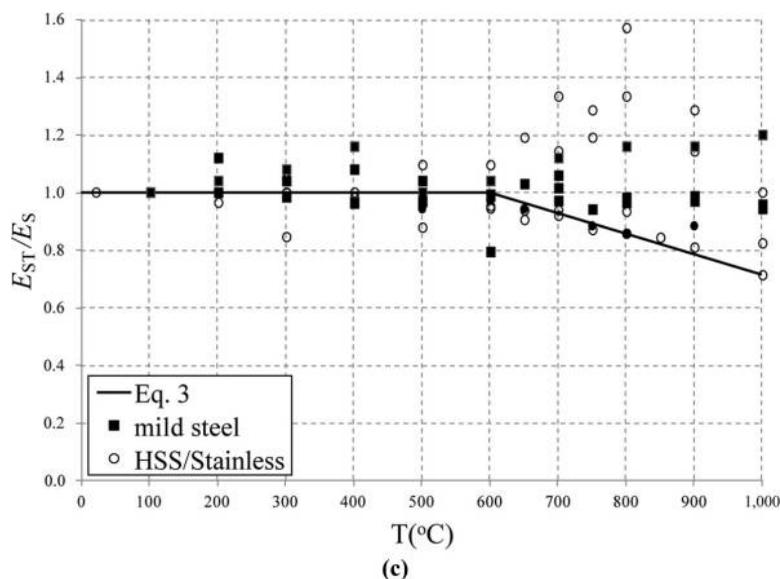
Figure 3.
The ratio of (a) f_{yT}/f_y ,
(b) f_{uT}/f_u and (c)
 E_{sT}/E_s as a function of
temperature for
hot-rolled steel

The experimental ratios of f_{yT}/f_y , f_{uT}/f_u and E_{sT}/E_s for hot-rolled steel are plotted in Figure 3, where f_y, f_u and E_s are the reference yield strength, ultimate strength and elastic modulus (i.e. before the fire exposure), respectively, while those with the subscript T are the corresponding temperature-dependent values.

Equations (1)-(5) define the potential predictions and are compared with the test data. Equations (1)-(2) are the most accurate ones according to all test data with mild steel, but

sometimes overestimate the strength of HSS. Equations (4) and (5) are recommended for practical use to determine the residual yield and ultimate strength of high strength, alloy and stainless steel after cooling down from fire temperatures up to 1,000°C.

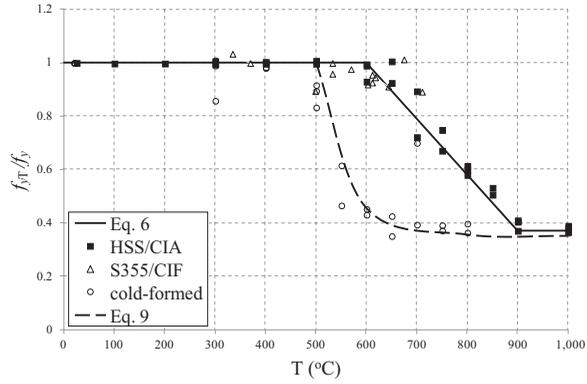
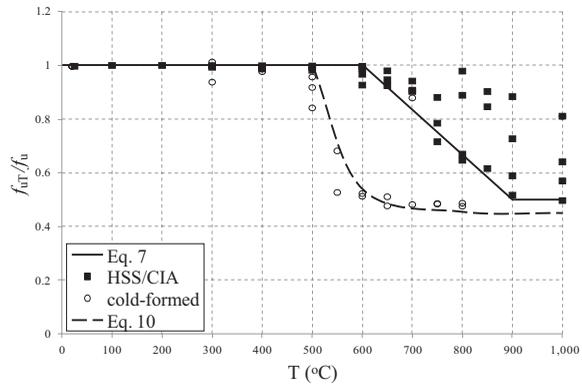
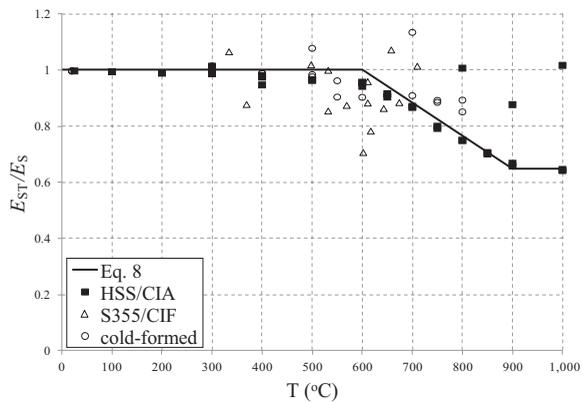
Figure 4. Comparison of predicted residual factors (a) f_{yT}/f_y , (b) f_{uT}/f_u and (c) E_{sT}/E_s for heat-treated and cold-formed steel

Post-fire mechanical properties for heat-treated steel are defined by equations (6)-(8). An obvious difference between cold-formed and heat-treated steel is apparent in terms of yield and ultimate strength (Outinen and Mäkeläinen, 2004; Gunalan and Mahendran, 2014; Wang *et al.*, 2014). Therefore, the residual capacities for cold-worked steel, the sudden decrease of which is clearly illustrated in Figure 4, are established by equations

It is concluded that the post-fire behavior of structural steel is hardly influenced after exposure to temperatures up to 500°C. In addition, the residual ultimate strength of mild steel is found to be greater than 90 per cent of the initial one, whereas none of the properties of hot-rolled steel is reduced more than 25 per cent. The distinction between mild steel and HSS is also stated in Appendix B of British Standards 5950-8 (Institution BS, 2003), which recommends the reuse of steel grades S235 and S275, following a 10 per cent reduction in the initial strength. On the other hand, for steel grade S355, at least 75 per cent of the strength is regained on cooling from temperatures above 600°C, which is in agreement with the experimental results (Smith *et al.*, 1981; Lee *et al.*, 2012; Qiang *et al.*, 2012) (Figure 3). On the other hand, it is worthy to note that these suggestions are considered as non-conservative for heat-treated (Qiang *et al.*, 2012, 2013) and cold-worked steel, as the deterioration of the capacity is more significant (Figure 4; residual factors over 35 per cent).

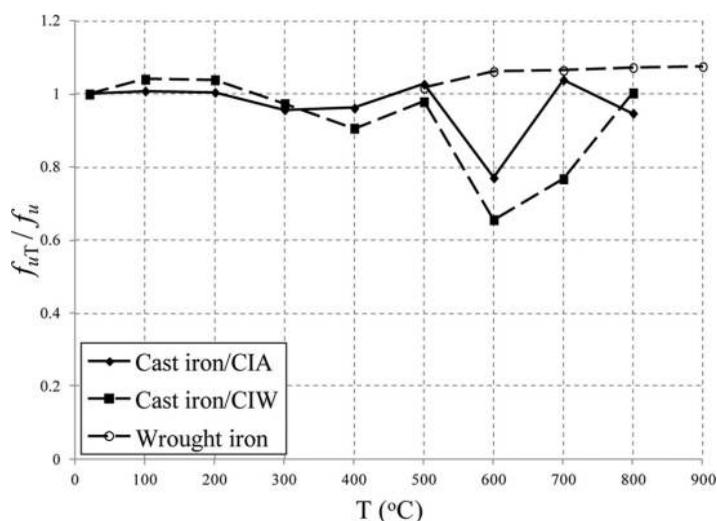
Figure 6. Residual factors f_{uT}/f_u for (a) cast iron (Maraveas *et al.*, 2015) and (b) wrought iron (Kirby *et al.*, 1986)

Wrought and cast iron materials have been widely used in historical structures Maraveas *et al.*, 2015, the preservation of which should be taken into account after fire events. Their post-fire behavior was observed by Kirby *et al.* (1986). Nevertheless, no experimental data are available nowadays, except the recent results conducted by Maraveas *et al.* (2015). The work conducted in this paper demonstrates the mechanical behavior of cast iron under high temperatures and after cooling to ambient temperature. The results indicate deterioration in capacity only for temperatures between 600°C and 700°C. Oppositely, wrought iron demonstrates the same mechanical behavior after cooling from elevated temperatures (Kirby *et al.*, 1986). The observations above are graphically displayed in Figure 6.
